# WESTBURY, OIL TANK LEAK REMEDIATION

Client	MAN Truck & Bus Ltd
Location	Westbury
Remediation Value	£15,500
Project	Removal of hydrocarbon impacted soils following a leak of c.800 litres of engine oil
Contaminant	Hydrocarbons

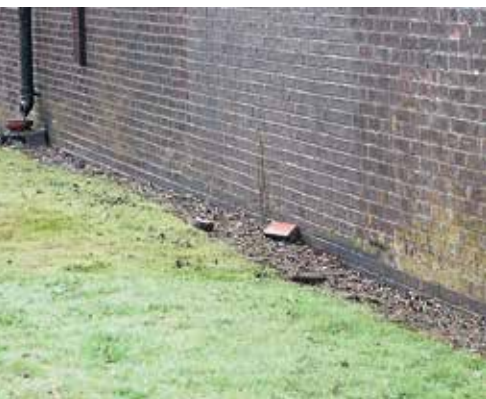
Area of spillage and damaged wall

During high winds a roof from a lean-to was blown off and damaged a pressurised pipe that fed a workshop with engine oil from a storage tank, which spilled c.800 litres of oil over a wall onto the highway verge.

The client was keen to remove the impacted soils as soon as possible to reduce the risk of the migration of contamination but during the incident the lean-to roof had damaged the boundary wall to the yard in the vicinity of the spillage.

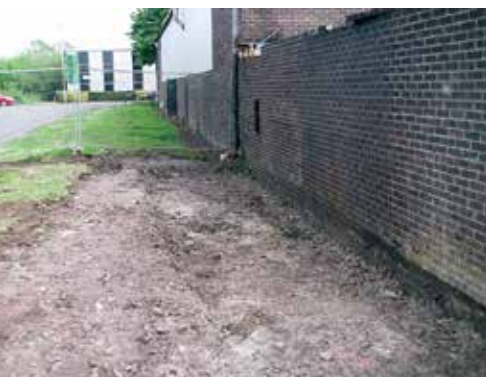
Stepped excavation

As it was unknown when the wall would be repaired to facilitate the early completion of the remedial works, UK Remediation Limited implemented a series of working methods that reduced the amount of vibration by using small capacity excavators (2t) working at arm's length perpendicularly to the wall.

Also during the works the impacted soils were excavated in 200 mm thick layers and were limited to 400 mm deep adjacent to the wall.
