# WESTBURY, OIL TANK LEAK REMEDIATION

Client	MAN Truck & Bus Ltd
Location	Westbury
Remediation Value	£15,500
Project	Removal of hydrocarbon impacted soils following a leak of c.800 litres of engine oil
Contaminant	Hydrocarbons

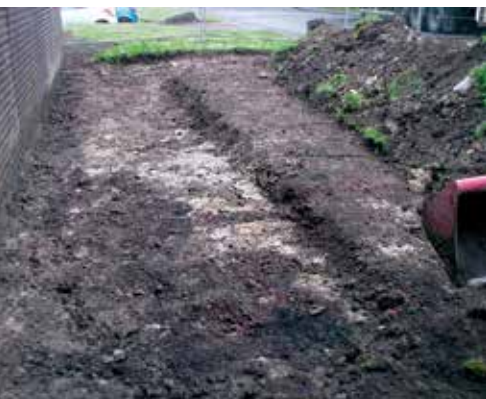
During high winds a roof from a lean-to was blown off and damaged a pressurised pipe that fed a workshop with engine oil from a storage tank, which spilled c.800 litres of oil over a wall onto the highway verge.

The client was keen to remove the impacted soils as soon as possible to reduce the risk of the migration of contamination but during the incident the lean-to roof had damaged the boundary wall to the yard in the vicinity of the spillage.

As it was unknown when the wall would be repaired to facilitate the early completion of the remedial works, UK Remediation Limited implemented a series of working methods that reduced the amount of vibration by using small capacity excavators (2t) working at arm's length perpendicularly to the wall.

Also during the works the impacted soils were excavated in 200 mm thick layers and were limited to 400 mm deep adjacent to the wall.
